RI 9085

Bureau of Mines Report of Investigations/1987

Fire Tests of Rigid Plastic Ventilation Ducts

By F. J. Perzak, C. P. Lazzara, and T. A. Kubala

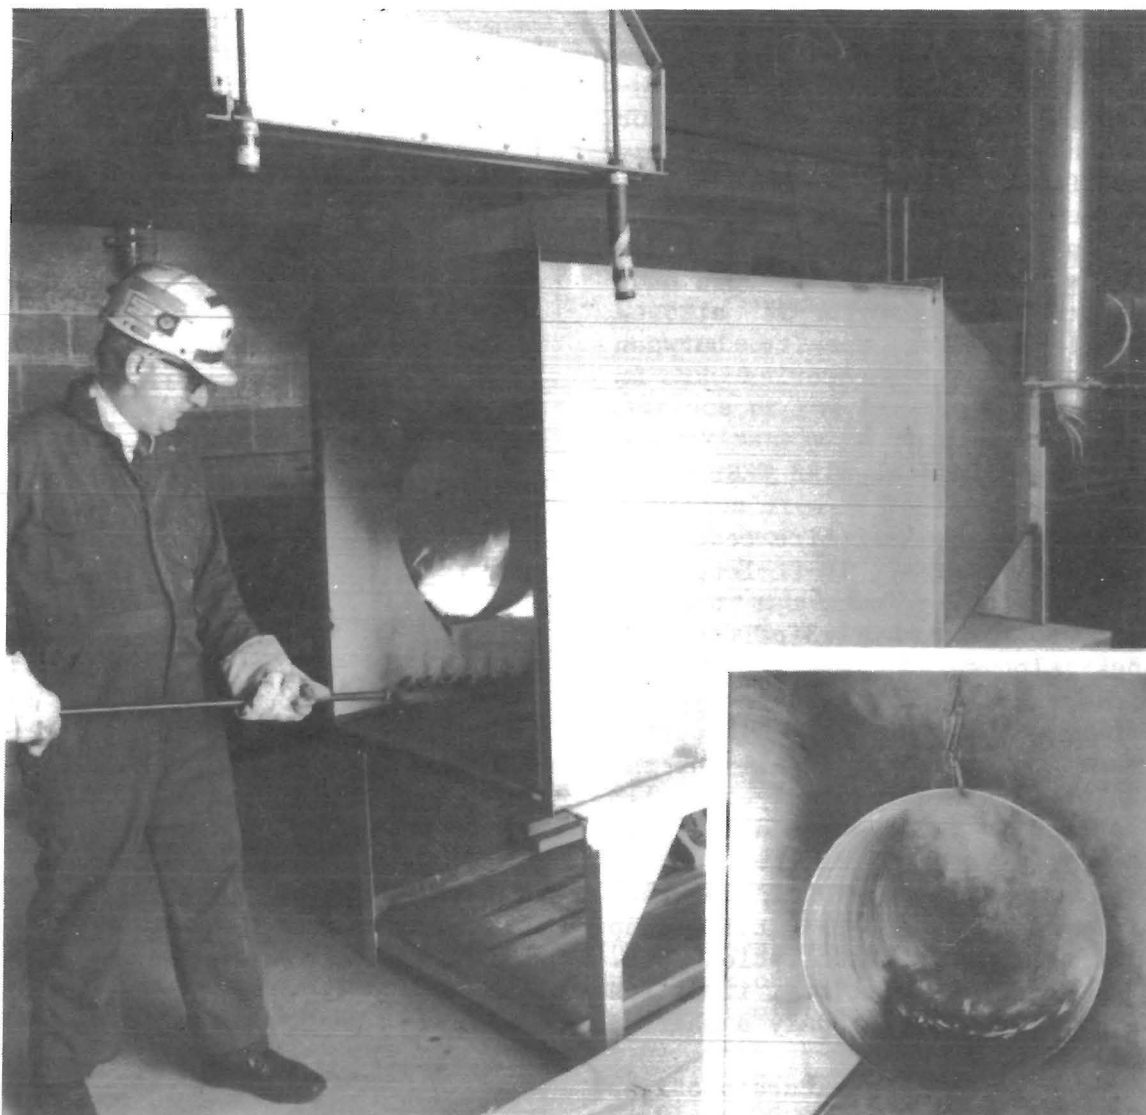
FIGURE 1.—Ignition of 16-in-diam FRP duct in the standardized small-scale flammability test apparatus. Insert shows flaming duct 2 min after burner removal.

The S³FT apparatus consists of an insulated ventilated tunnel, 5 ft long by 3.5 ft high and 2.5 ft wide. A 4-ft-long by 16-in-diam duct sample without flaired ends or support rings is suspended horizontally in the center of the tunnel. The ignition source is a 12-jet gas burner that delivers 26 kW over a 4-in-wide by 12-in-long area (12-in-high flame). The burner is positioned beneath the lower edge of the duct sample so that two-thirds of the burner flame is under the tubing and the remaining one-third of the flame is allowed to lick into the inside of the tubing. The burner flame is held in contact with the duct for exactly 1 min. The tunnel ventilation flow is controlled to give 0 or 125 ft/min air velocity over the suspended duct sample. Figure 1 shows the ignition of a 16-in-diam duct sample. The insert shows the duct flame 2 min after the removal of the burner.

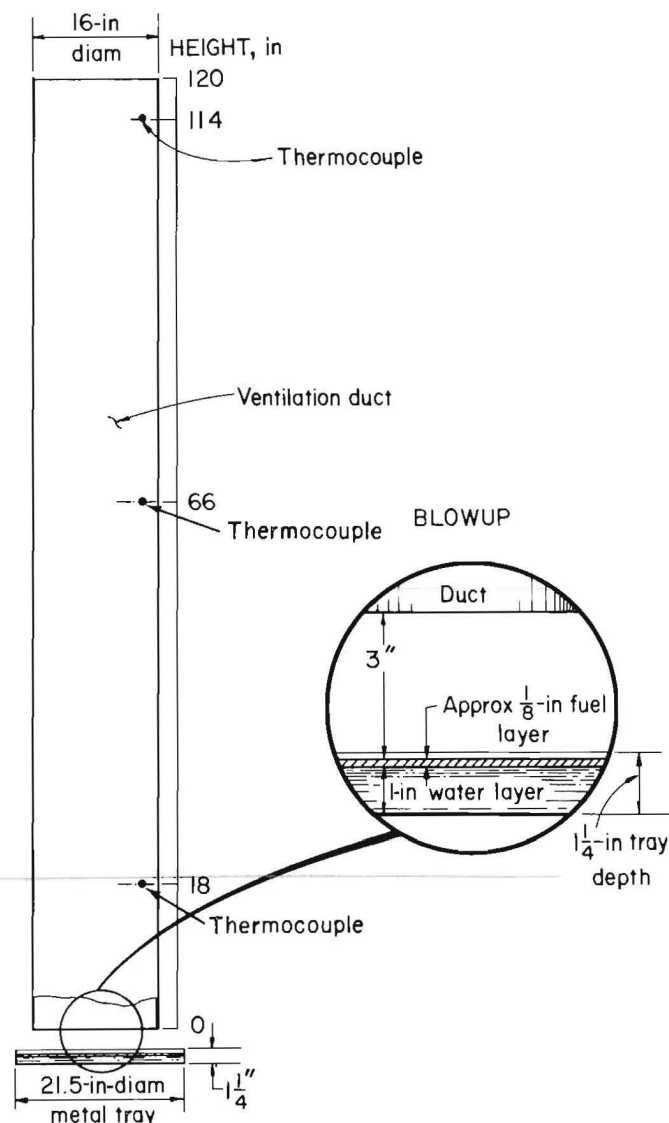
FIGURE 2.—Schematic view of setup for large-scale vertical fire test of ventilation duct.

The large-scale vertical fire test consisted of a 16-in-diam, 10-ft-long duct suspended vertically over a nominal 22-in-diam pool fire of 1.3 pt (600 mL) of heptane. In a few tests, the duct was instrumented with 20 gage type K thermocouples with their beads inserted about 2 in from the inside wall of the duct. The pool fire burned for about 1.3 min. Blank trials using steel ducts gave temperatures at the top of the duct as high as 1,000° C in about 40 s. Figure 2 shows a schematic view of the test setup for a 10-ft-section of ventilation duct. A duct failed the vertical test if it was consumed by flames leaving only a charred fiberglass carcass.

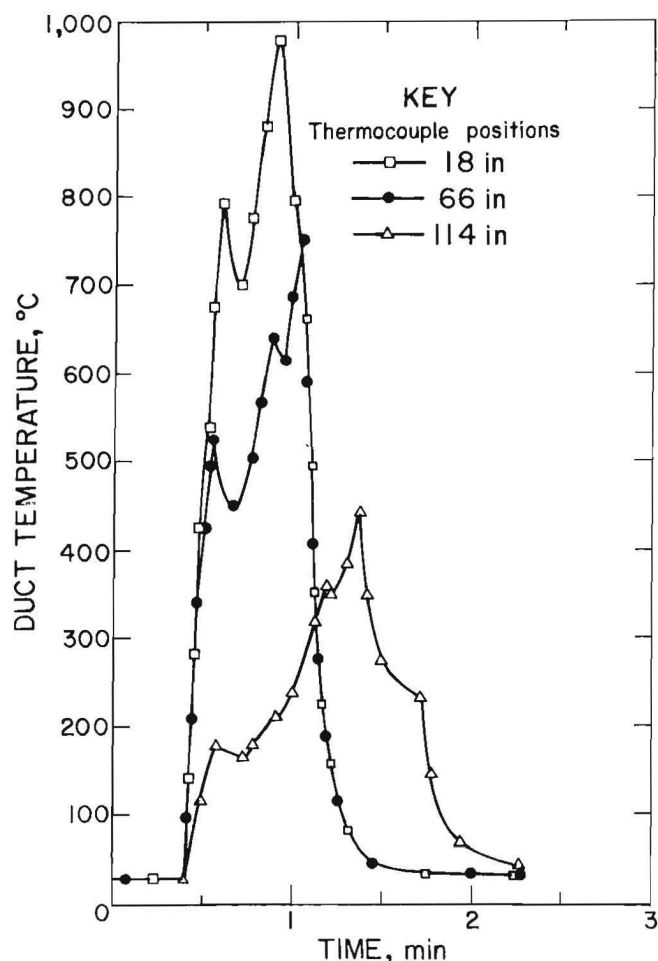
FIGURE 3.—Temperatures inside duct C during vertical fire test. Thermocouple heights measured from bottom.

Figure 3 shows the temperature profiles at three locations for duct C. The data record starts at zero time; however, the igniter began at about 0.4 min. The sudden drop in temperature about 0.8 min is probably due to the flame bursting through the walls. The heptane igniter was out at about 1 min. Figure 4 shows the vertical fire test for duct C. Panel A shows the duct at ignition. After 30 s, the exterior surface is engulfed in flames (panel B) and at about 1 min (panel C) the duct collapses leaving fiberglass ribbons (panel D). Approximately 22 pct of the weight of the original duct was consumed in about 2 min or less, with the generation of large quantities of black, acrid smoke. Several tests were made with duct C at a 45° angle with similar results as the vertical test. The combustible products were not analyzed.

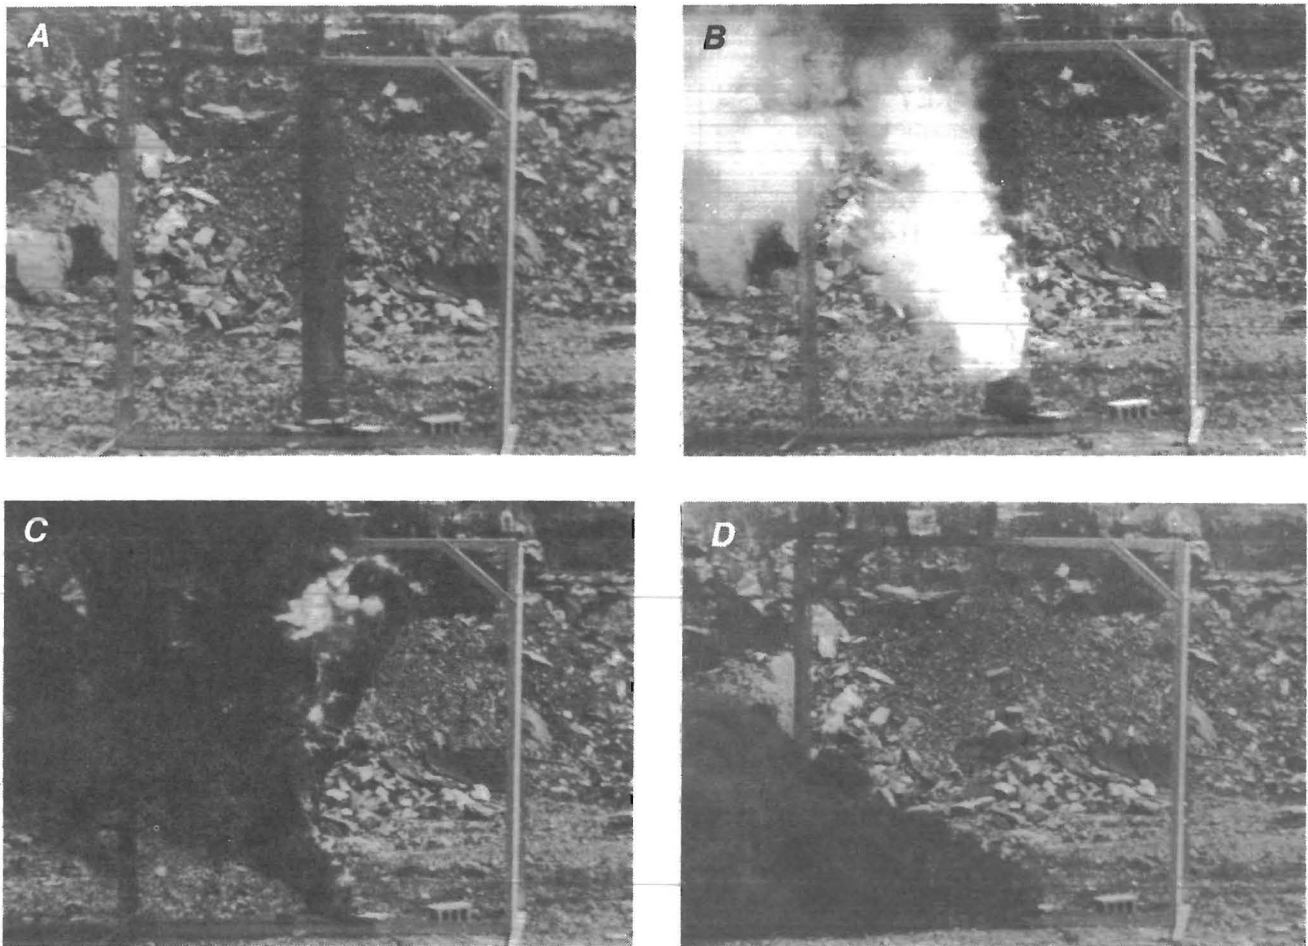
FIGURE 4.—Vertical fire test of duct C. A, At ignition; B, flashover of exterior surface at 30 s; C, collapse of duct at about 1 min; D, smoking remains at 1.8 min.

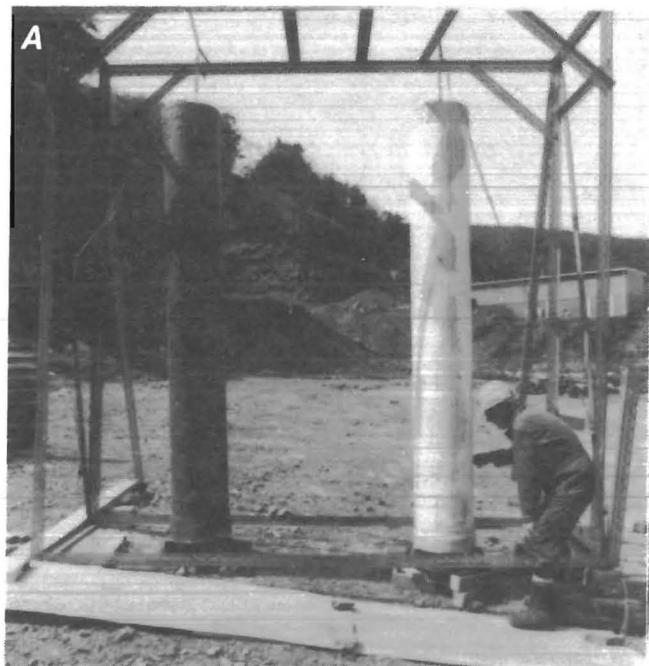
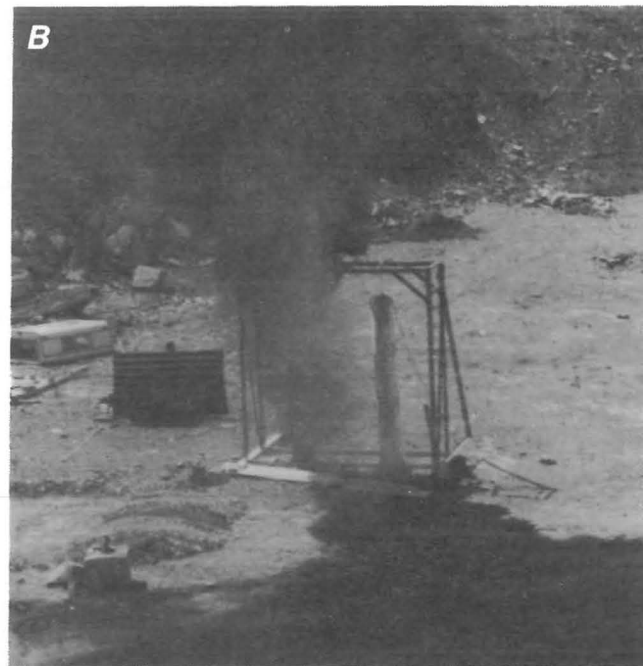
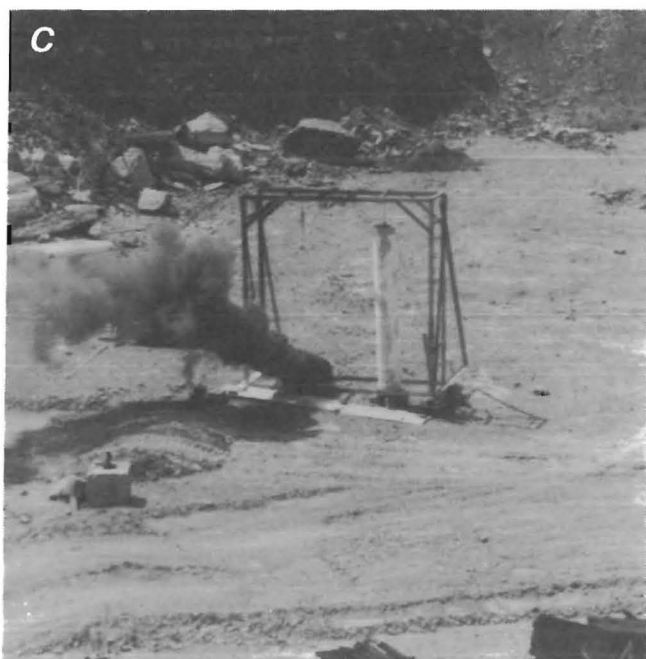
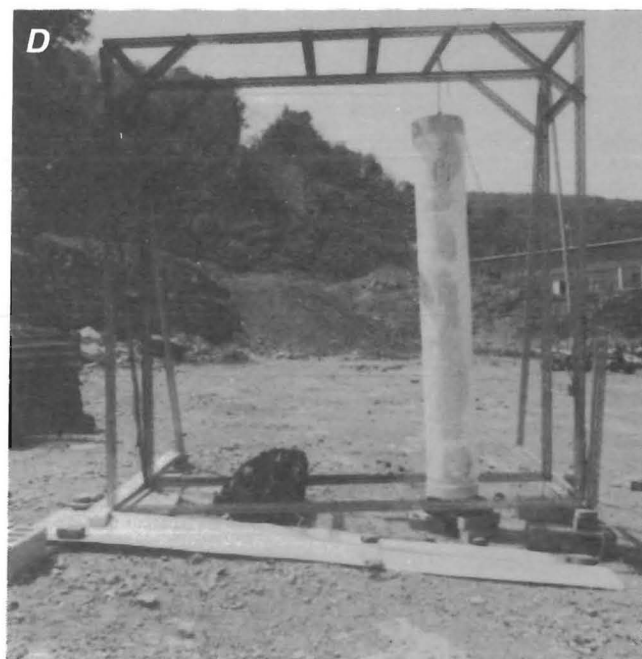
FIGURE 5.—Vertical fire test of duct A (right side) and duct C. A, Before ignition; B, 76 s after ignition; C, 90 s after ignition; D, after test.

Ducts A and C were tested simultaneously in the vertical configuration. Figure 5 shows the vertical fire test for ducts A and C. Panel A shows the experimental setup before ignition with duct C on the left side. Panels B and C show the ducts at 76 s and 90 s, respectively, after ignition. Duct A on the right was virtually undamaged, but duct C was consumed by the flames. Ducts B, D, E, and F behaved similarly to duct C and failed the vertical fire test. Duct A was the only one that passed the test. For the five ducts that burned, weight losses varied from 22 pct for duct C to 34 pct for duct

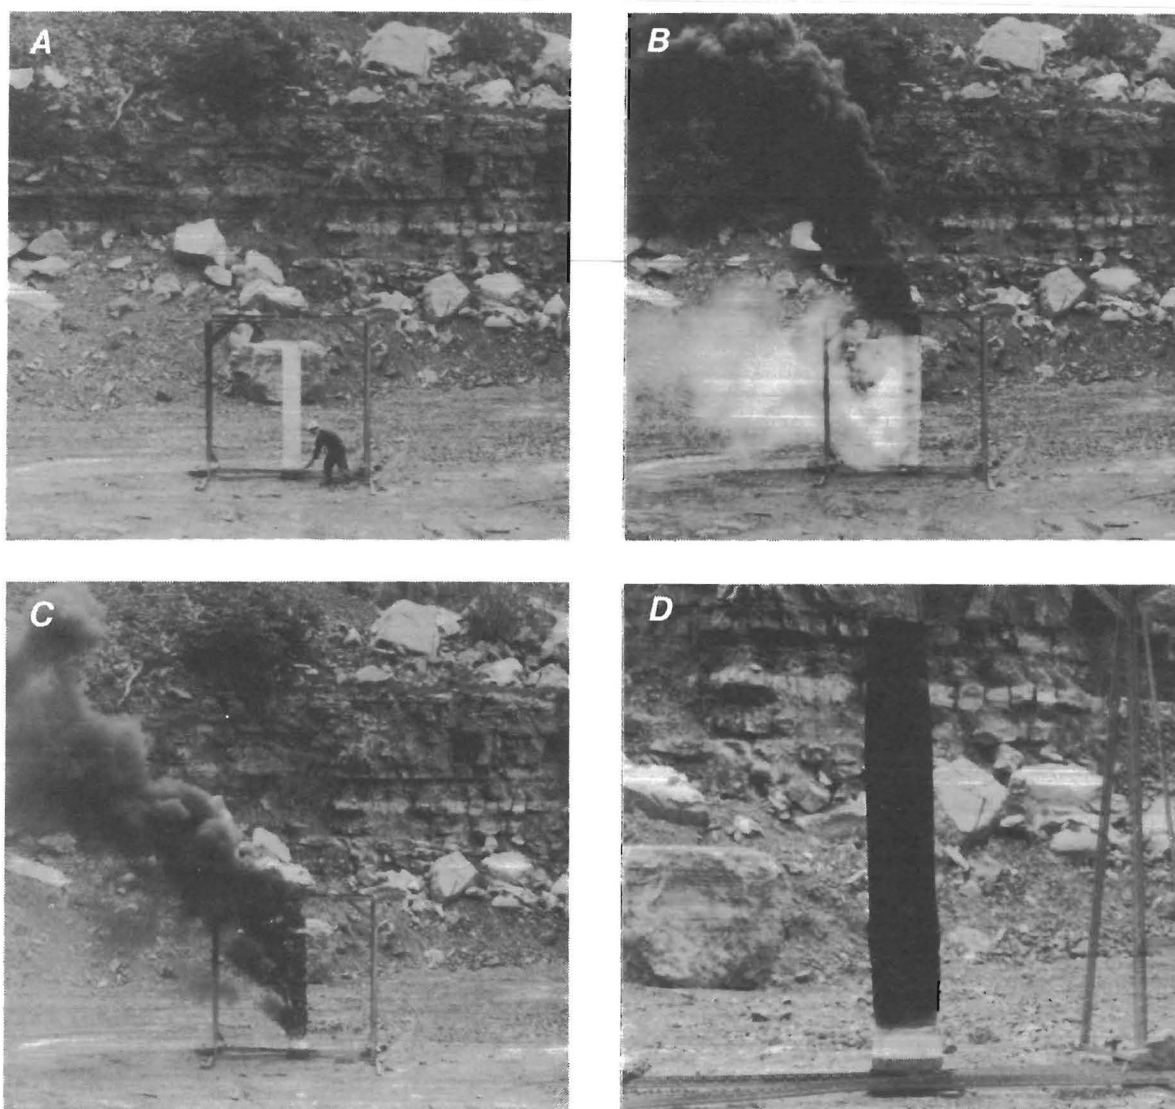
FIGURE 6.—Vertical fire test of duct F. A, At ignition; B, 57 s after ignition; C, 108 s after ignition; D, after 4 min.

The results of a large-scale vertical fire test of duct F are described in detail in table 4 where the temperatures at a position 6 in from the top inside the duct and comments of significant events are given. Figure 6 shows the vertical fire test of duct F.

Time, min:s	Temperature, ¹ °C	Event
0:00	20	Tray fire ignition (figure 6, panel A).
:34	470	Black smoke from top of duct.
:38	500	Flame 4 ft high inside duct.
:42	570	White smoke 2 ft up from bottom on outside of duct.
:46	600	Heavy black smoke from top of duct.
:57	942	Flame in smoke at top of duct (figure 6, panel B).
1:07	985	Duct sways and sags, smoke and flame from top.
1:16	1,010	Continuous flame from top of duct.
1:21	860	Tray fire out.
1:48	670	Entire duct on fire. Heavy black smoke (figure 6, panel C).
2:49	320	Duct burning at top 2 ft and bottom 1 ft.
3:28	210	Flame at top rim, and 2 ft down from top.
4:03	70	No flame visible (figure 6, panel D).

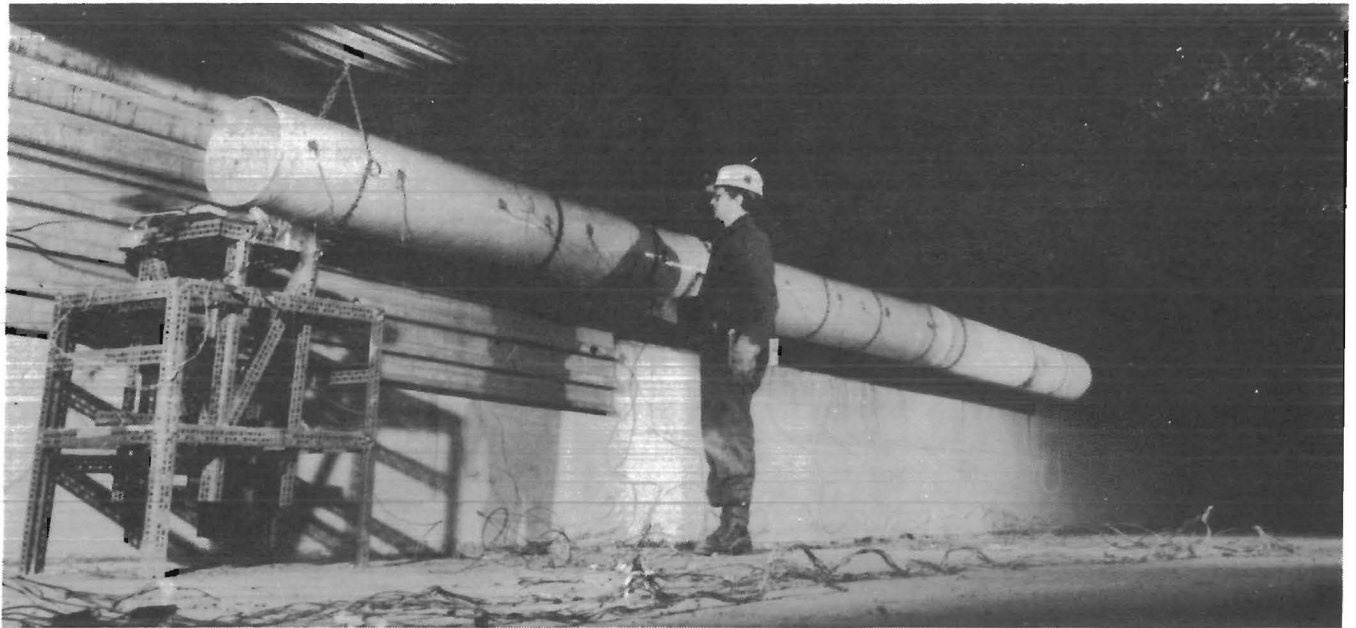
FIGURE 7.—Test arrangement for full-scale in-mine fire tests of ventilation ducts.

The ignition source was a 22-in-diam tray fire of 2.1 qt (2 L) of heptane. The 1.5-in-deep tray was supported by a metal stand and contained a layer of water on which the heptane was floated. The heptane pool was positioned 4 in below the upstream edge of the duct run with the end of the duct over the center of the pool. In this position, the pool flames impinged on the outer and inner duct surfaces. The heptane pool was remotely ignited by an electric match and burned about 3.5 min with a heat output of about 16,300 Btu/min. Figure 7 shows the test arrangement for the in-mine tests.

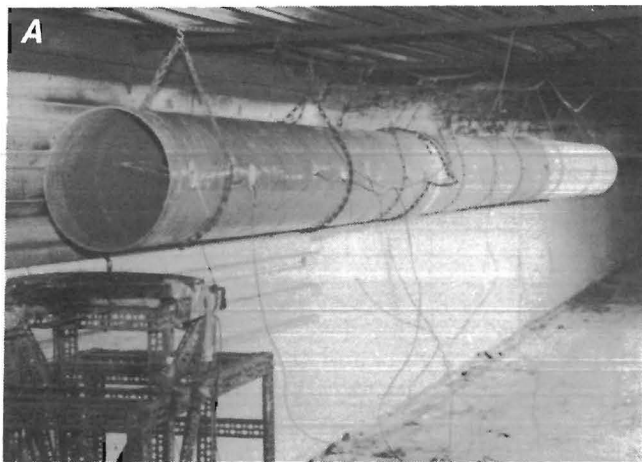
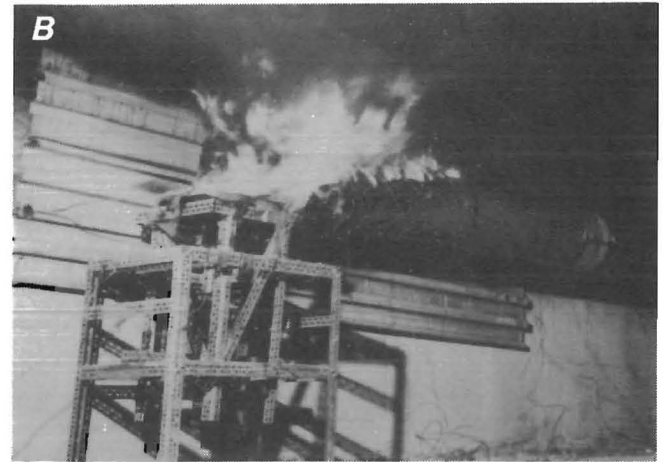
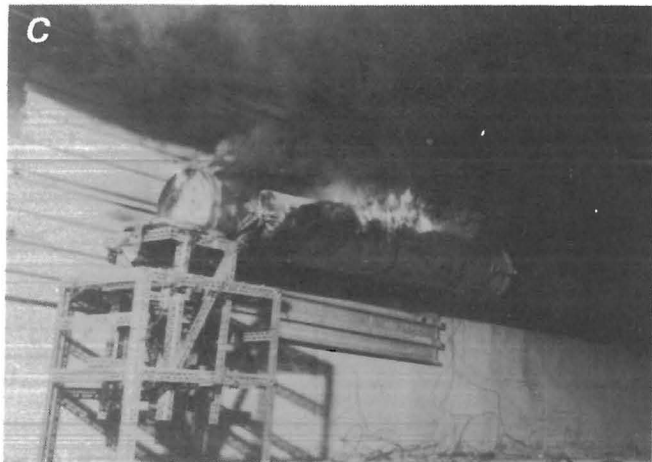
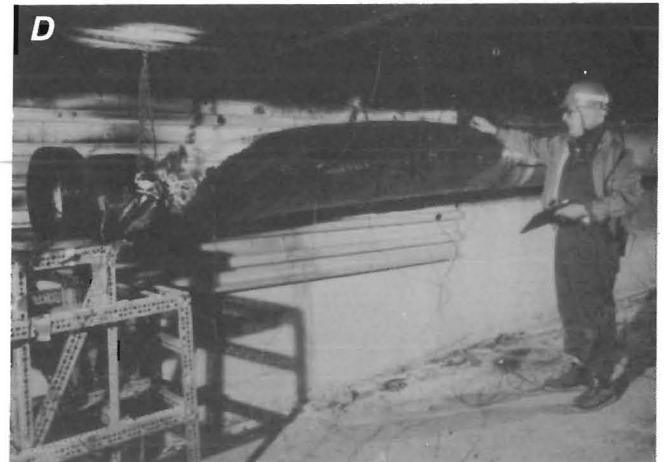
FIGURE 8.—In-mine fire test of duct D. A, Setup; B, 2.5 min after ignition; C, 3.5 min after ignition; D, duct after test showing extent of flame damage.

region where the pool flames contacted the duct. Duct D was ignited by the pool fire, but flames propagated only 8 ft along the top surface close to the roof. Figure 8 shows the in-mine fire test for duct D. Panel A shows duct D prior to the test, and panels B and C show the ducting at 2.5 and 3.5 min, respectively, after the heptane pool fire was ignited. The duct continued to burn along the top surface for another few minutes before the flames

self-extinguished. Panel D shows the ducting after the test.

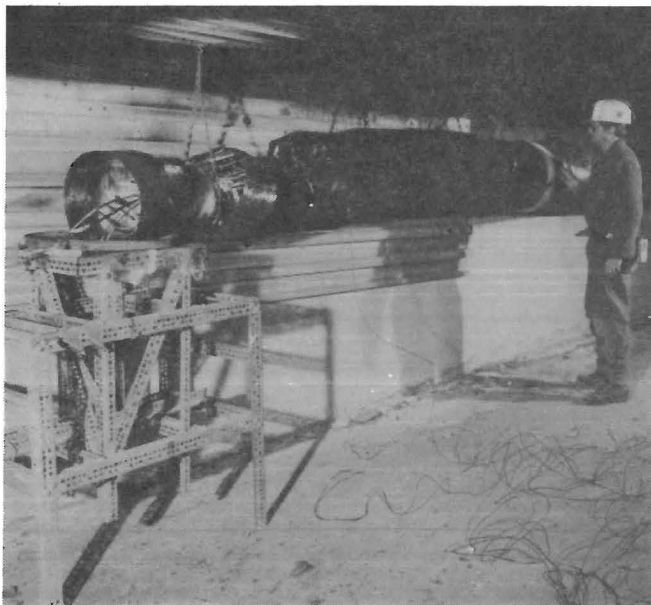
FIGURE 9.—Charred fiberglass carcass of duct F after in-mine fire test.

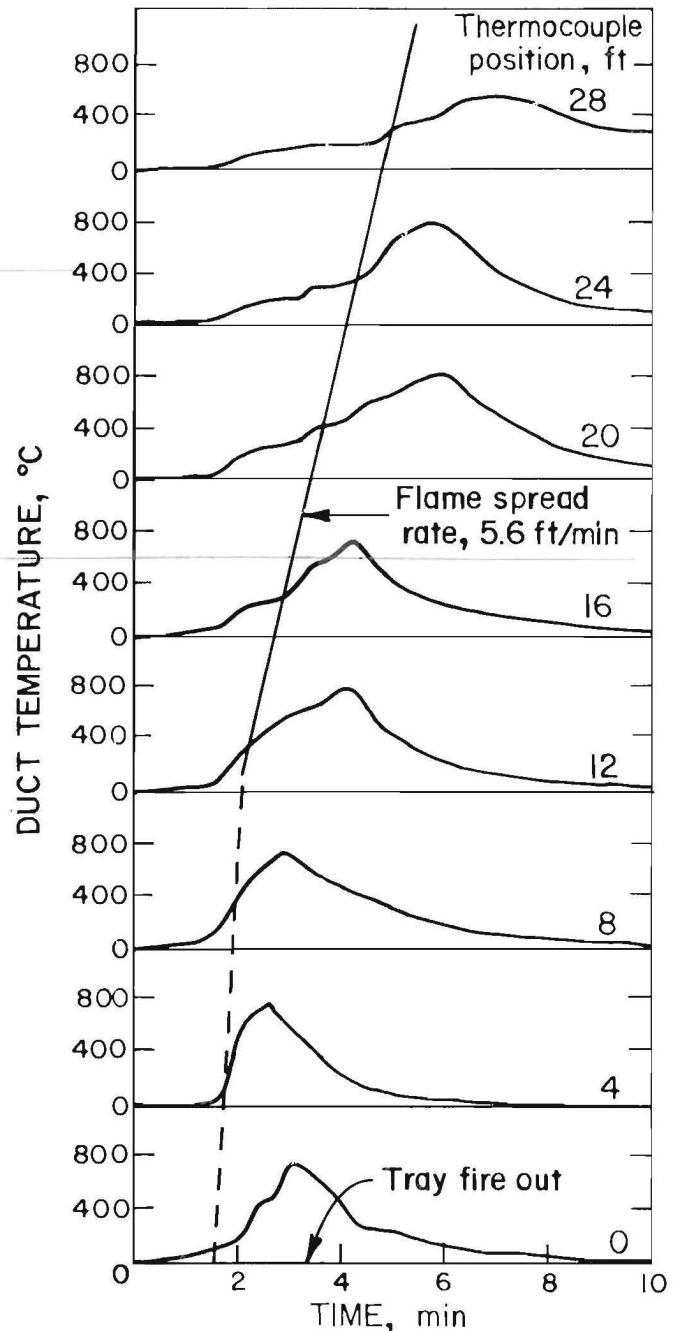
FIGURE 10.—Temperature-time profiles of duct B during in-mine fire test. Solid line indicates the flame position w/tn time during steady burning; dotted line indicates the erratic flame position during ignition.

Figure 10 shows the temperature-time profiles obtained from every other thermocouple during the in-mine test of duct B. As the flame spread down the duct, the thermocouples at each position indicated steadily increasing temperatures, which maximized at about 800° C and then fell after the burning subsided. A temperature of 310° C is used to signify the flame-front arrival at a thermocouple position. The best-fit straight line intersecting each profile at about the 310° C point (solid line in figure 10) indicates the region of steady-state burning and is used to determine the flame-front position as a function of

time and the flame spread rate. Deviation from this straight line, as indicated by the dashed line in figure 10, occurred during the ignition phase of the test.

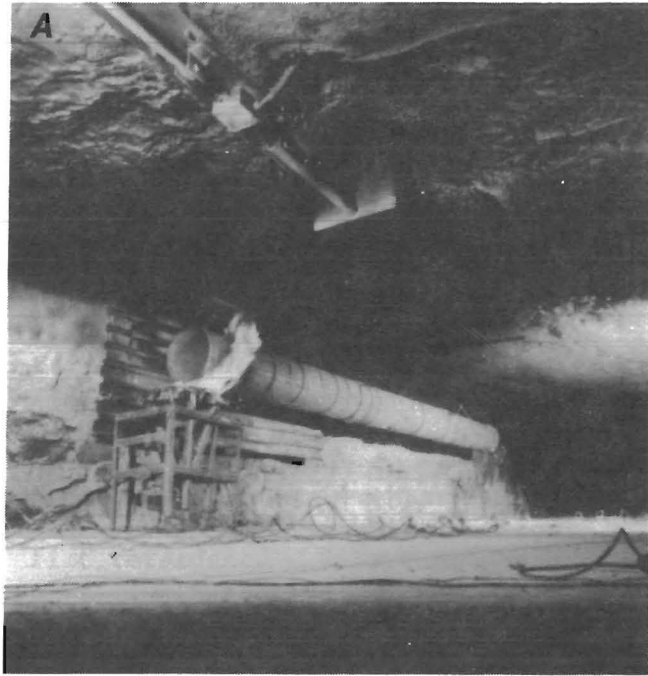
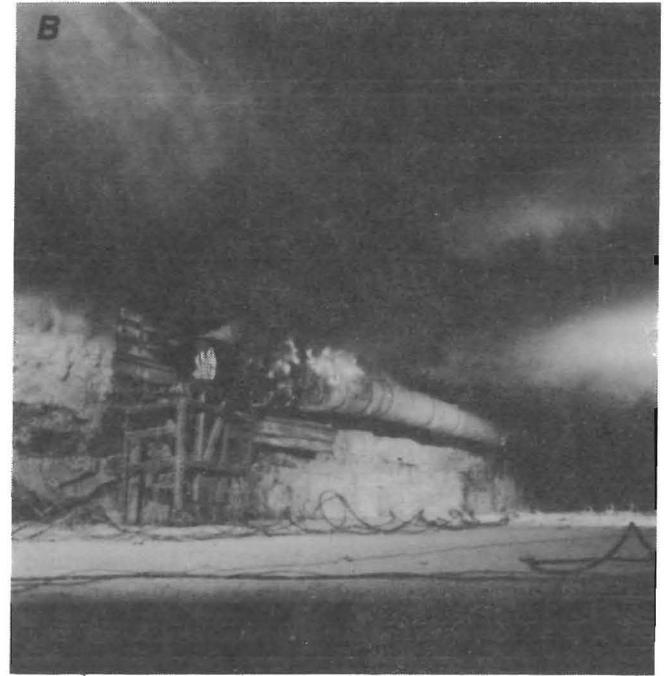
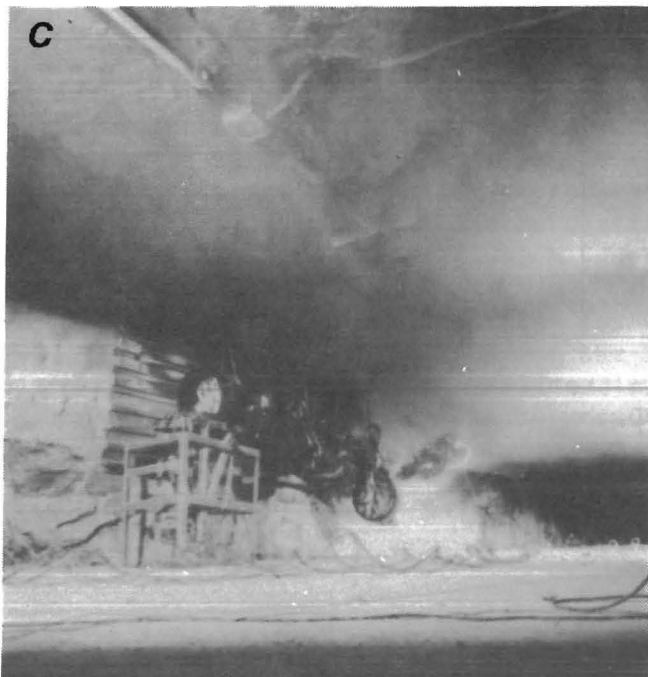
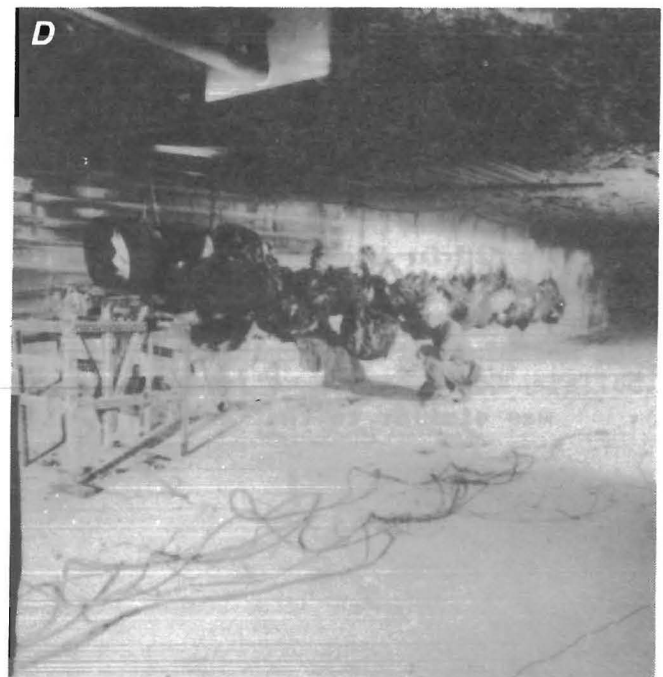
FIGURE 11.—In-mine fire test of 20-in-diam ventilation duct. A, Ignition; B and C, flame propagation; D, charred fiberglass carcass.

Panel A shows the start of the test. In panels B and C, the flame front is propagating down the ducting after the ignition source has burned out. Panel D shows the charred fiberglass remains after the test. Approximately 40 wt pct of the original 180 lb of ducting was burned in 16 min.

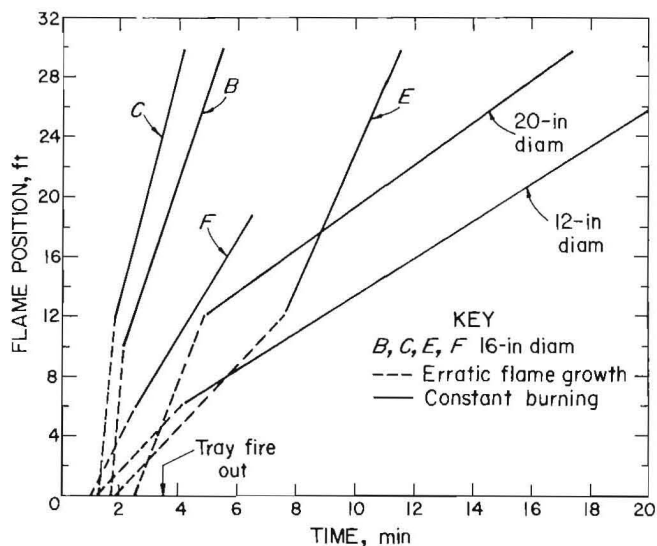
FIGURE 12.—Flame position versus time for in-mine fire tests of ducts that failed.

The flame position versus time for all the ducts that failed the in-mine test is shown in figure 12. The solid lines indicate steady-state flame spread and the slopes of the lines are the flame spread rates. The steeper slopes of most of the dashed lines are a result of the influence of the tray fire. Duct E took more time to reach steady-state burning than did the other samples. These apparent anomalies are expected since the processes that govern ignition and uniform flame propagation are different. Duct C had the fastest flame spread rate of 9.8 ft/min, two to three times greater than the other 16-in-diam duct samples. The flame spread rates of the 12- and 20-in-diam ducts are similar to each other and had the slowest flame spread rates measured in the in-mine tests.
